Overhaul Issues on Vertical Pumps

EPRI/NMAC Pump Users Group

August 10, 2004

***Kurt Schumann
ProPump Services***

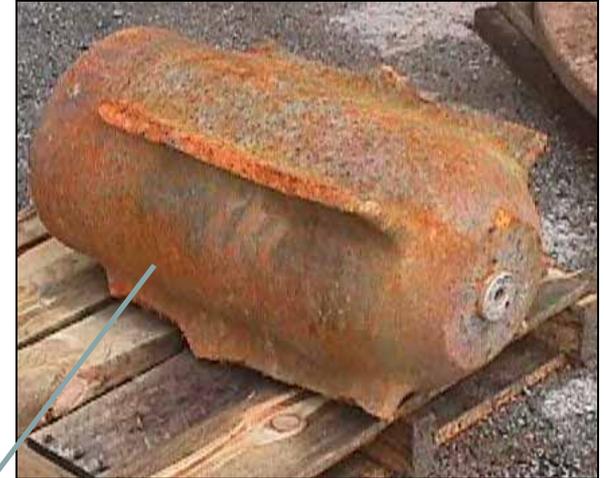
Bearing Holder

**Suction Bell with
Broken Ribs**

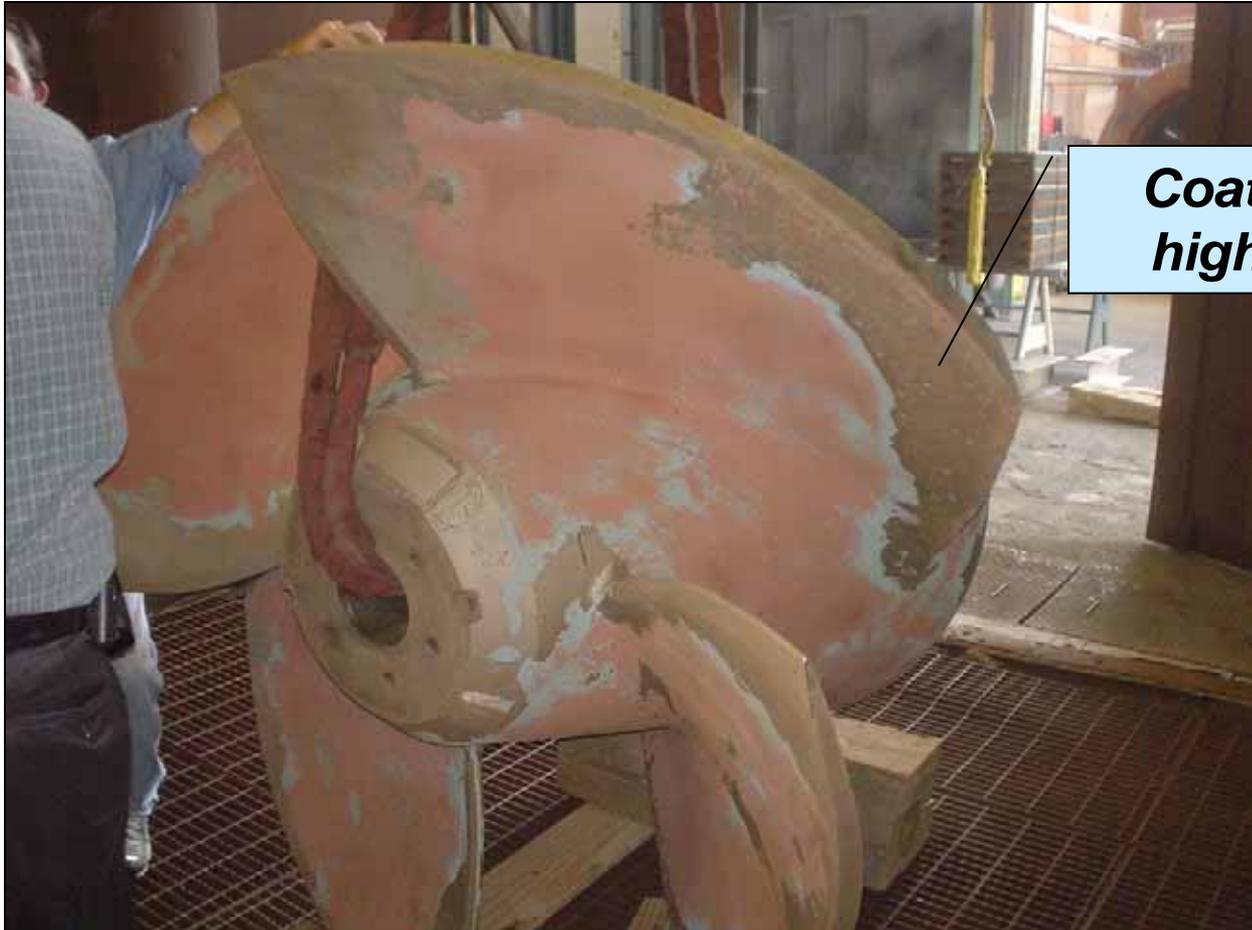
*Coating removed in
high velocity areas*

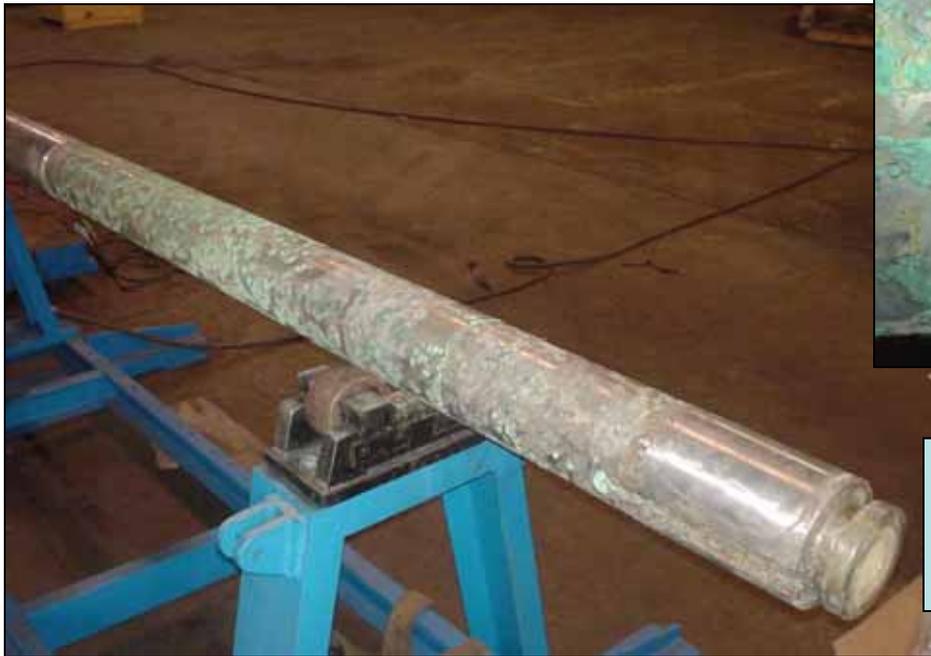
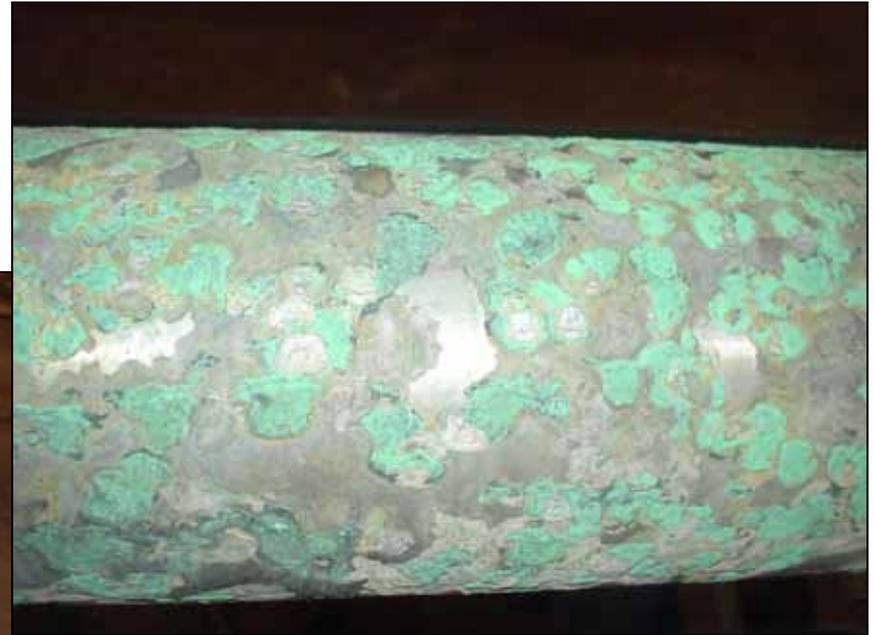
Shafts – Monel in Seawater

Copper Oxide Corrosion
Product – Deep Pits

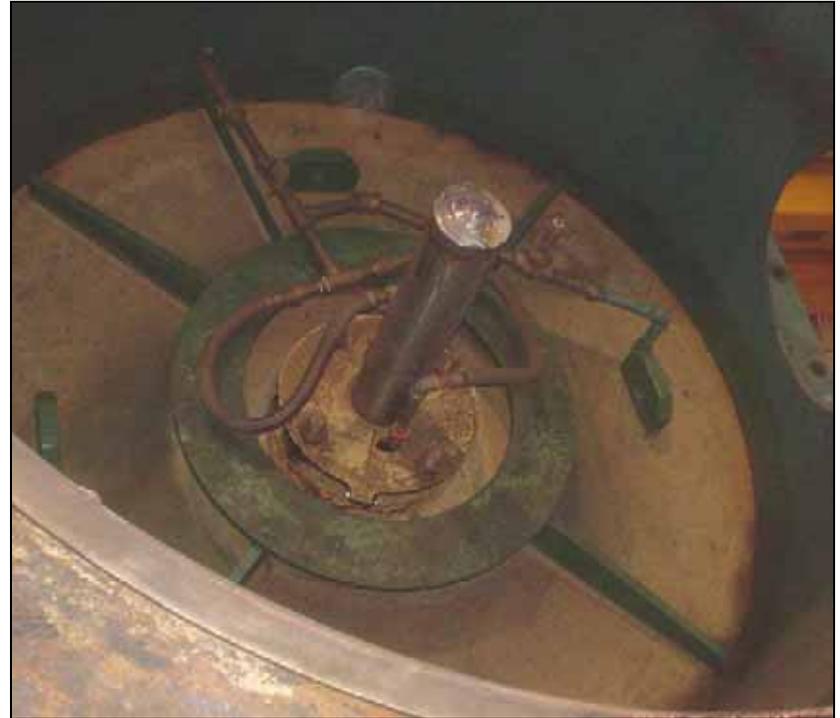
Broken Circulating Water Pump Shaft

- Pump shafts should never fail
- Design for stresses below endurance limit in liquid
- Watch sharp corners
- Some materials problematic

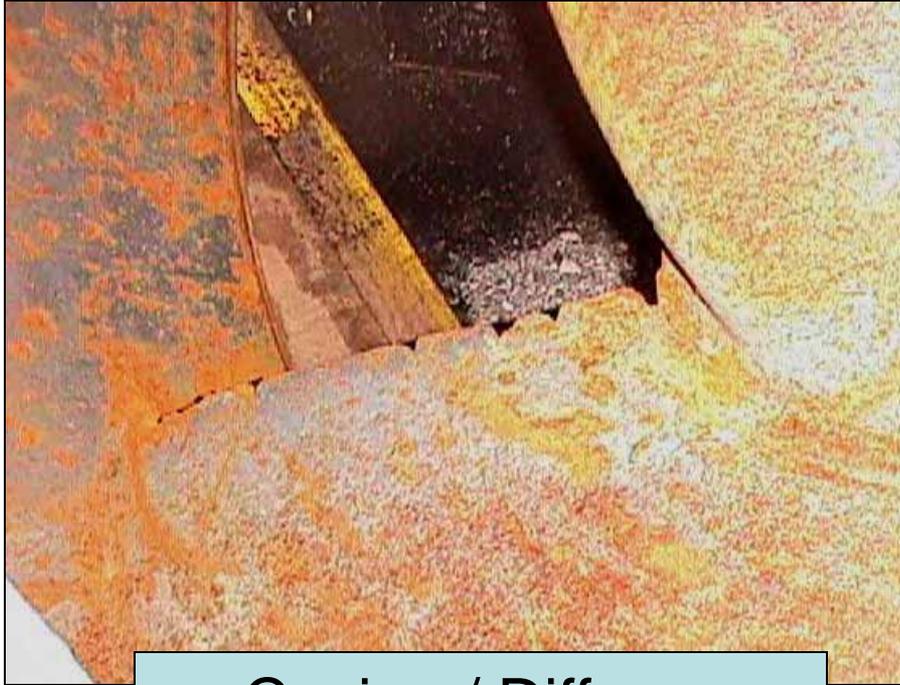
Casing / Diffusor

Erosion Damage

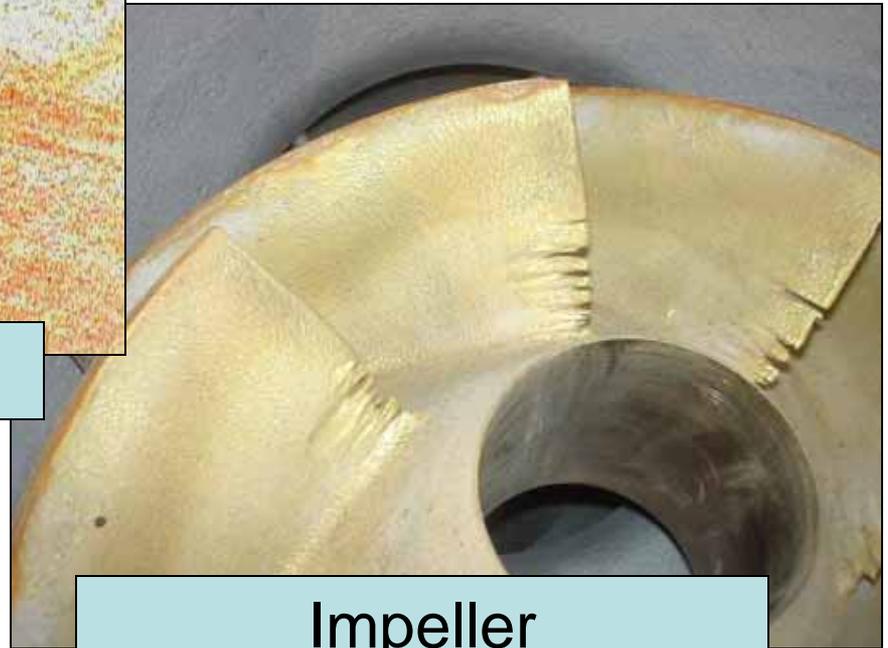
Impeller

Erosion Damage

- Symptoms
 - Vane Thinning
 - Saw Cuts at Leading Edge
 - Shallow pock marks
 - Scalloped leading edge

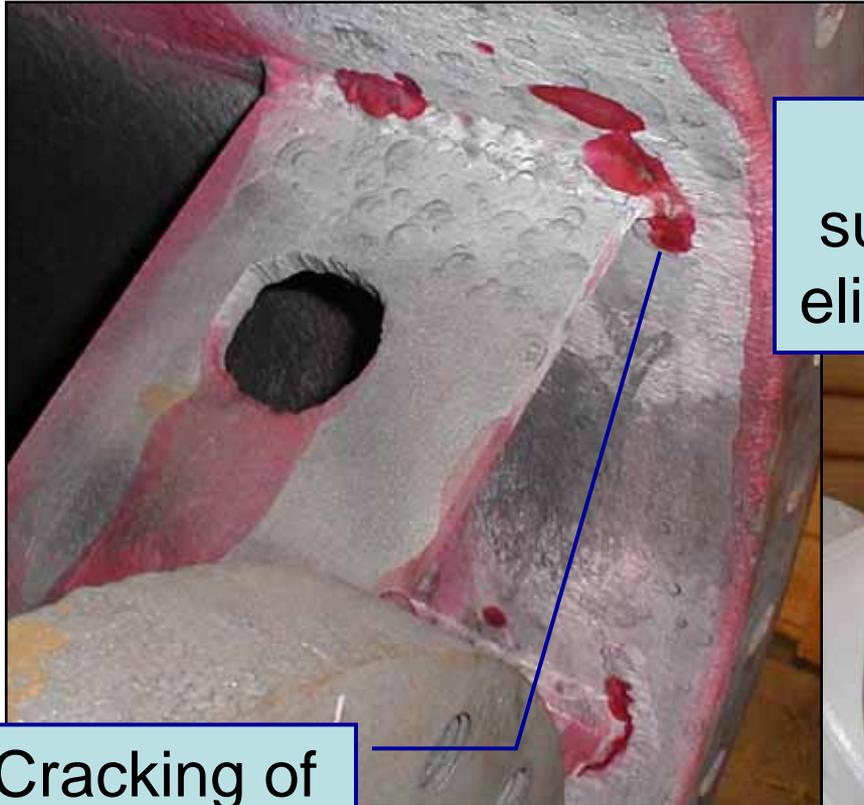
Cracking of support ribs

Beefed up support vanes to eliminate cracking

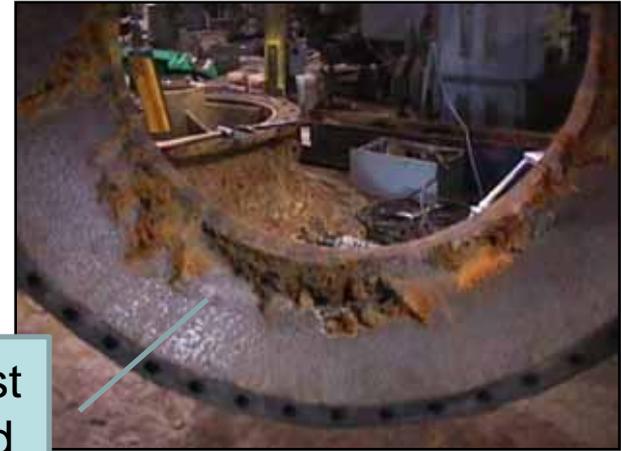
Eroded Cast
Iron Shroud

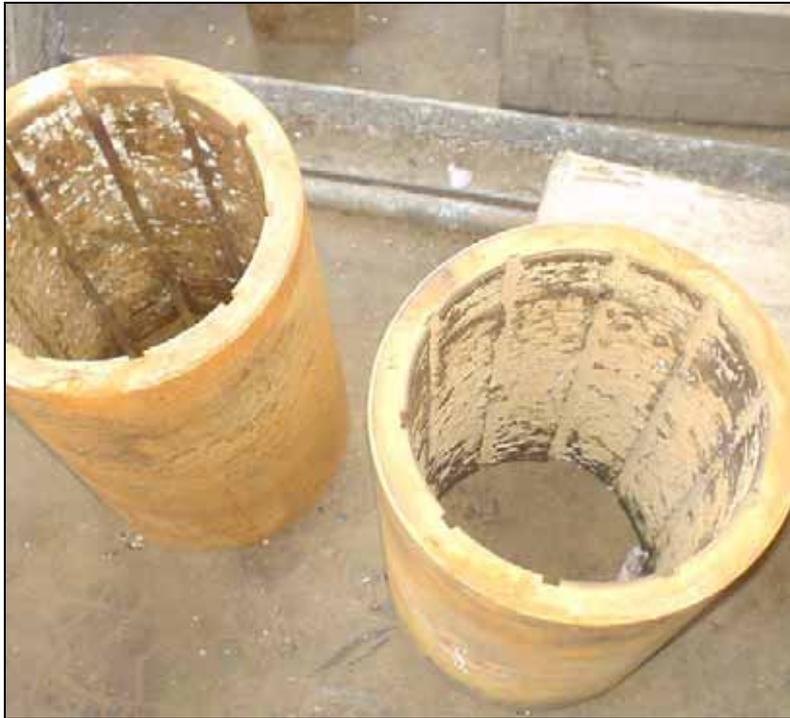
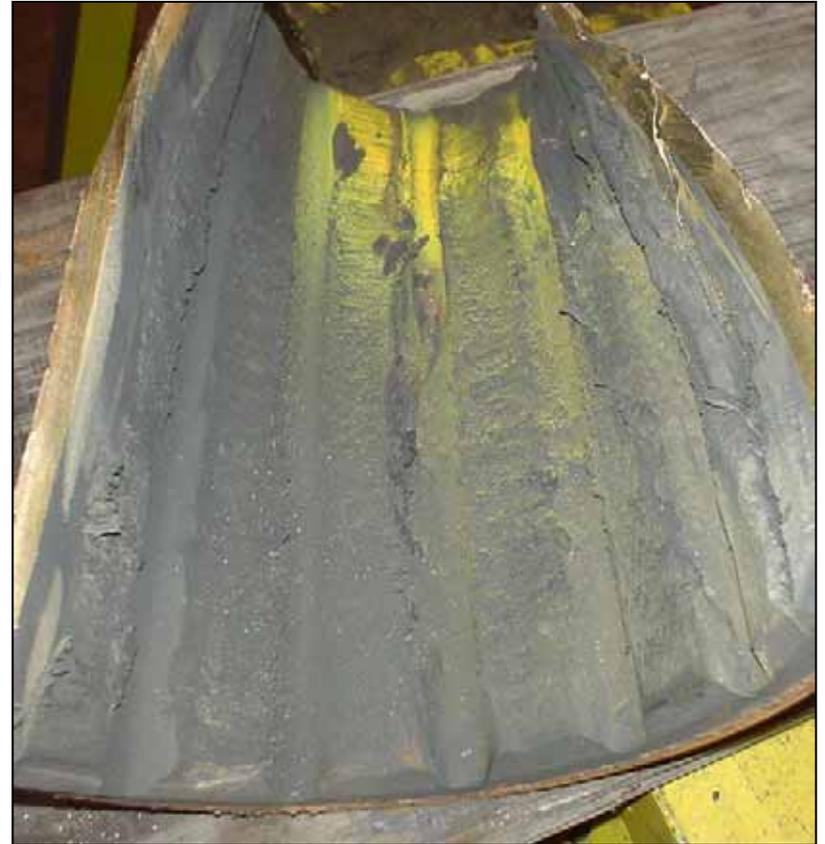
Bearings After Loss of Water Injection

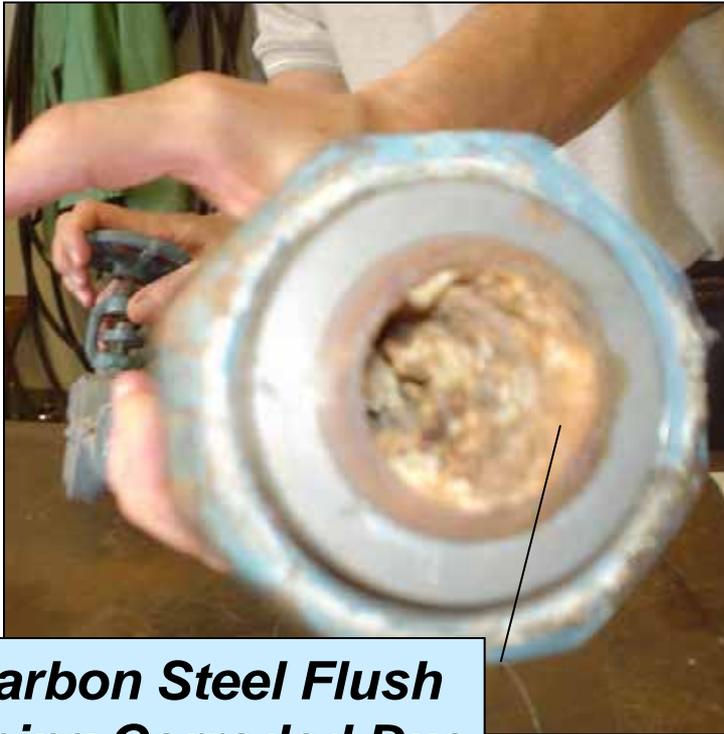
Bearing Flush Piping

Carbon Steel Flush Piping Corroded Due to Aggressive Water

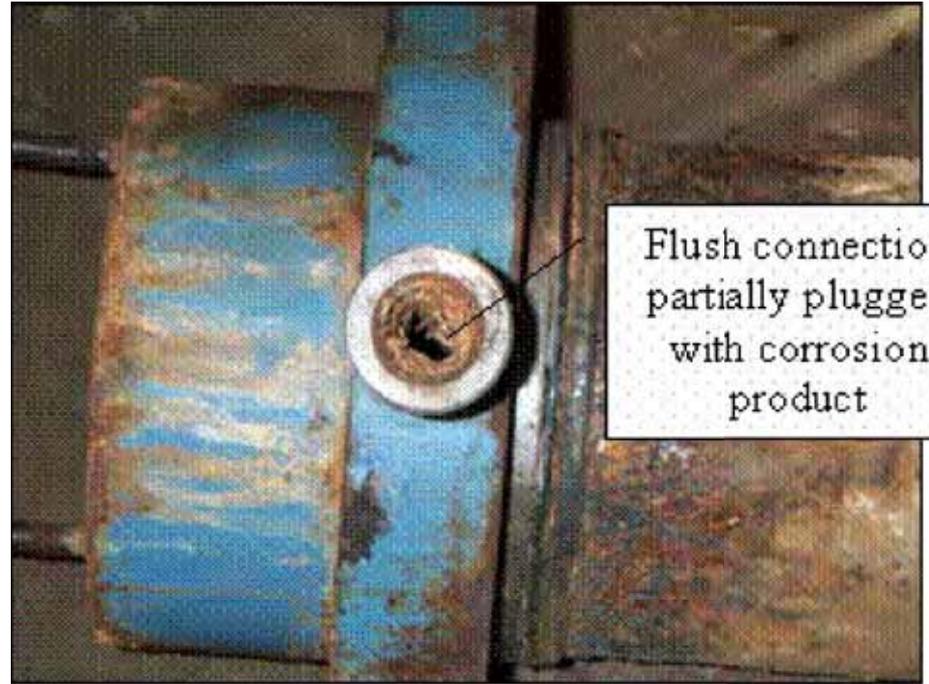
Flush connection partially plugged with corrosion product

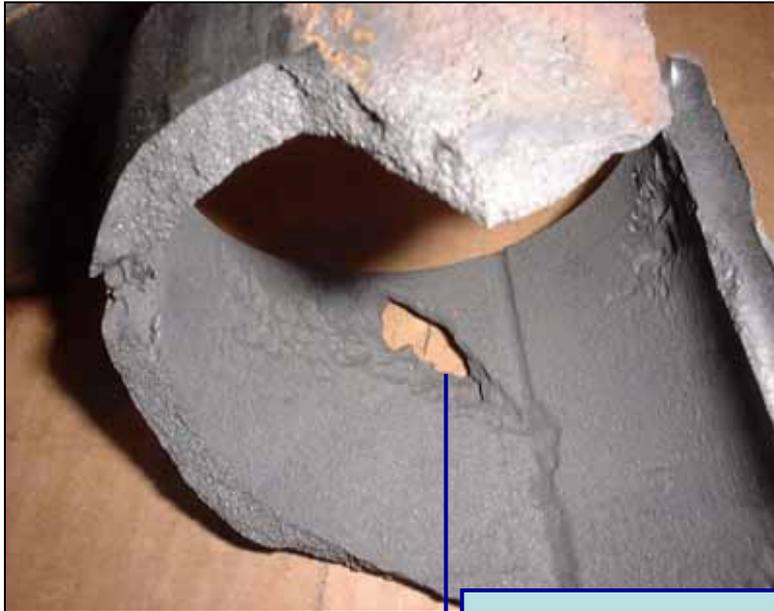
Cavitation damage to suction head bearing in Graphalloy material

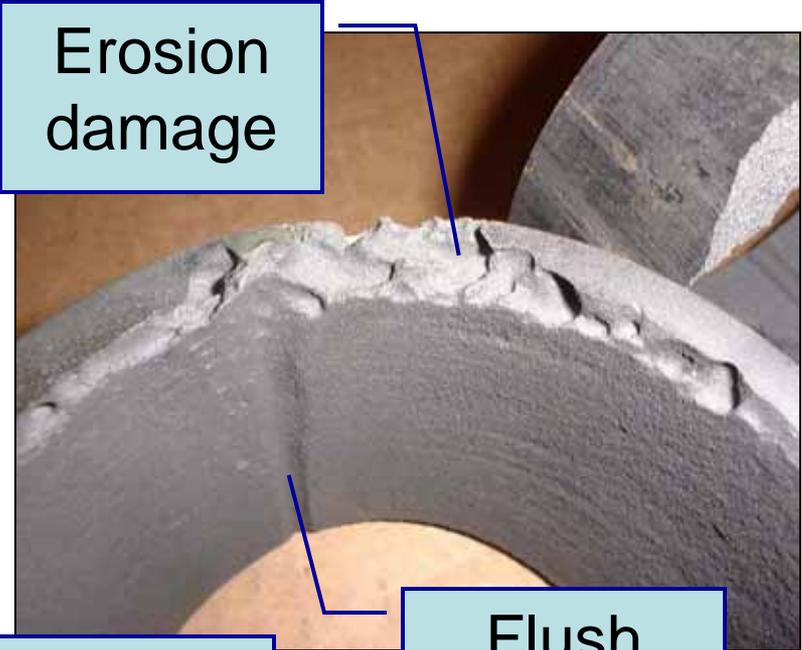
Erosion damage

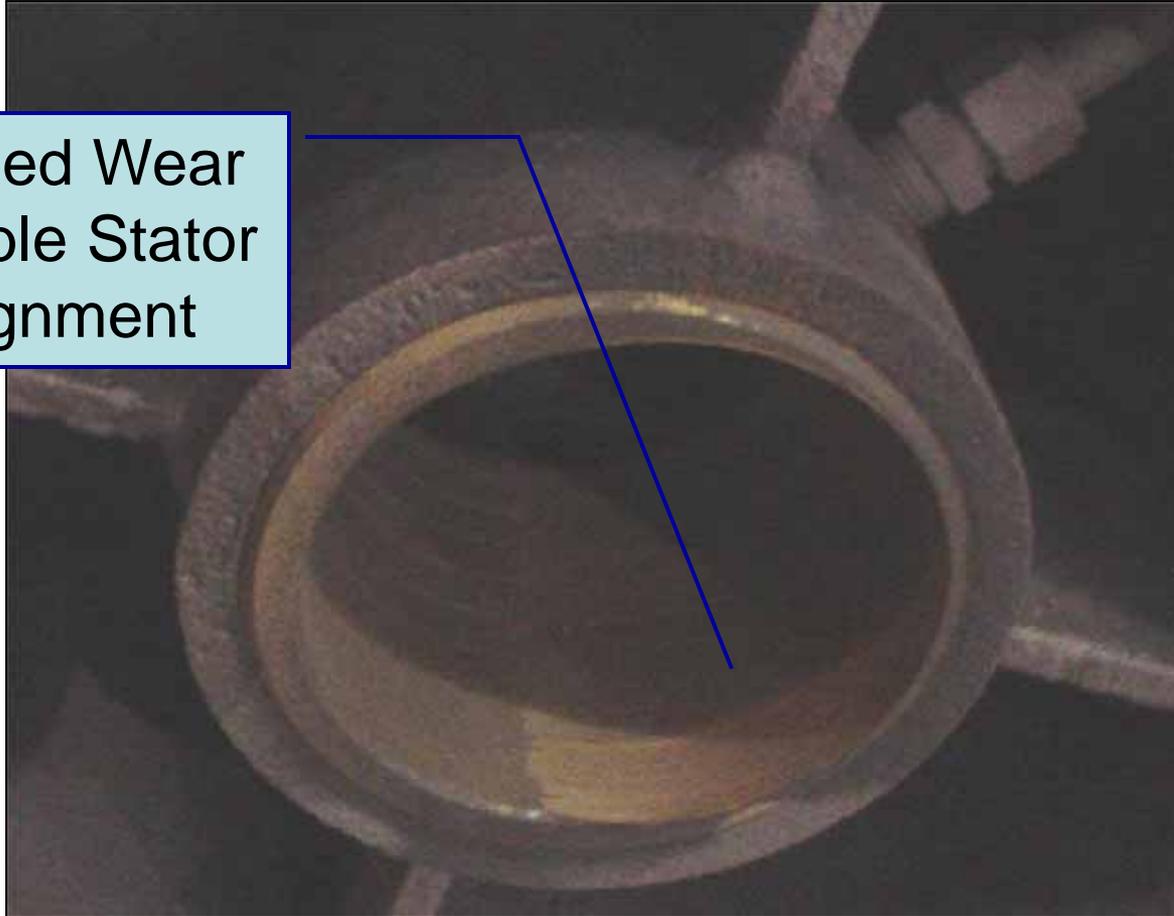
One Sided Wear
– Probable Stator
Misalignment

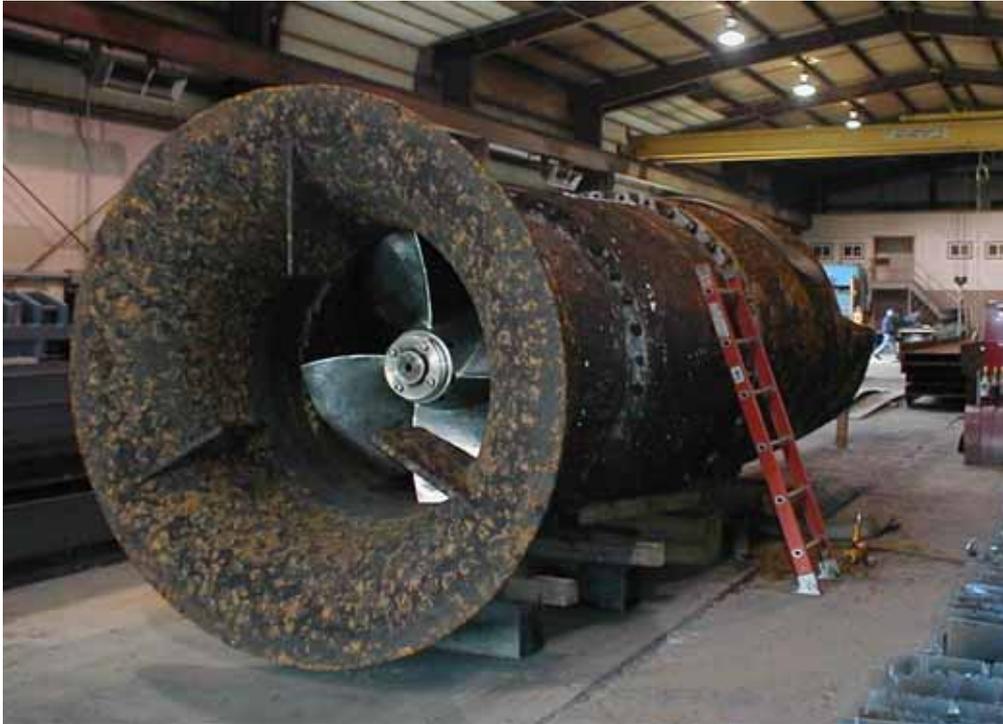
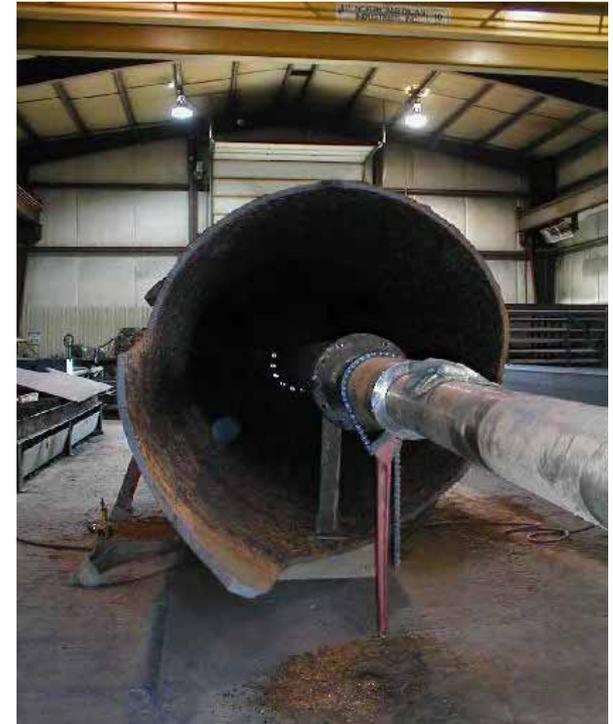
Dropped Circulating Water Pump

*Circulating Water Pump With
Broken Column*

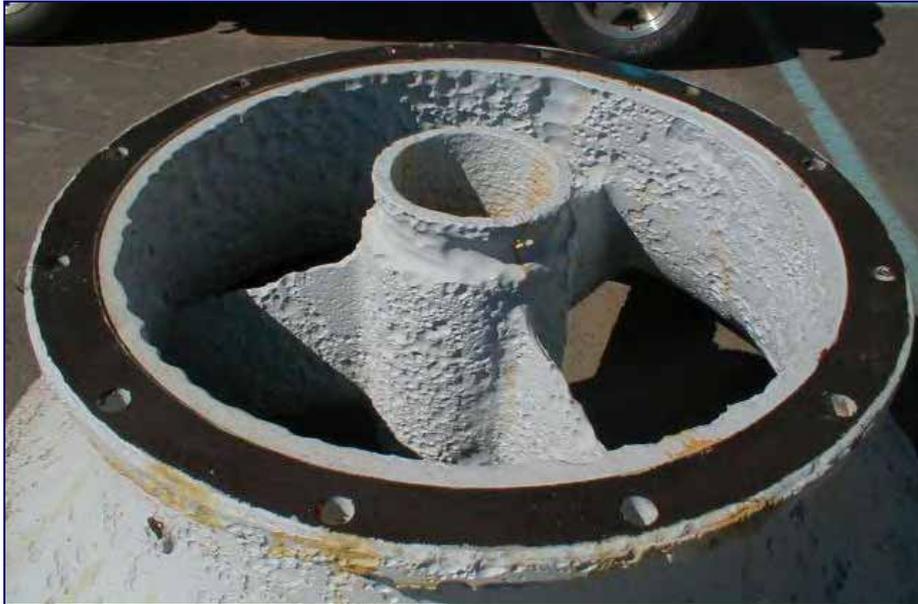
**Original Suction Bell in Cast Iron
Showing Corrosion Damage in
Seawater**

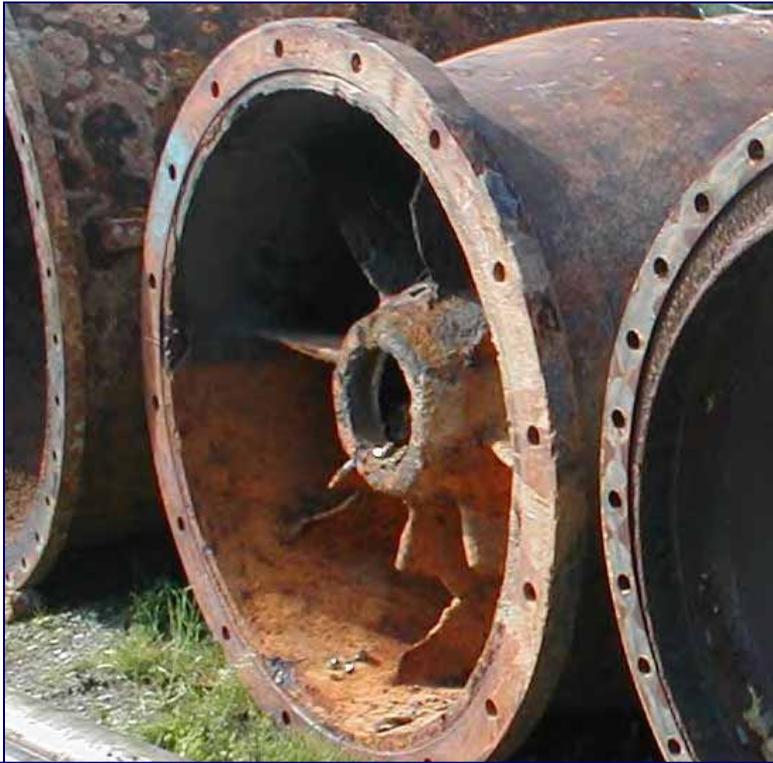
**Original Casing in Cast Iron
was Severely Corroded**

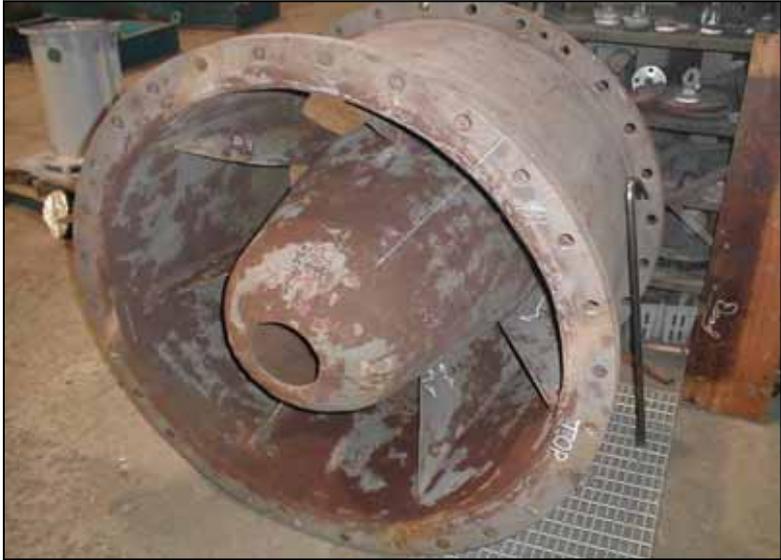
Cast Iron Diffusor with Erosion and Corrosion Damage
