Overhaul Issues on Vertical Pumps

EPRI/NMAC Pump Users Group

August 10, 2004

***Kurt Schumann
ProPump Services***

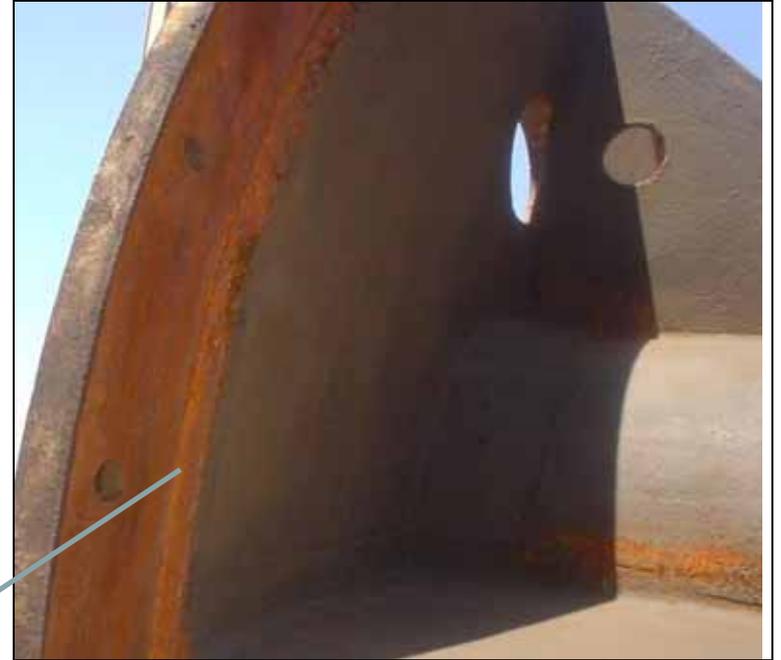
**Acceptable to
Weld Locating Fit**

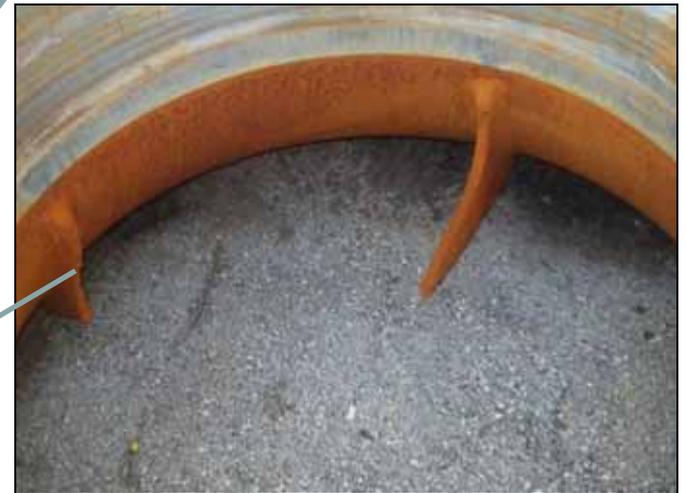
**Suction Bell with
Broken Ribs**

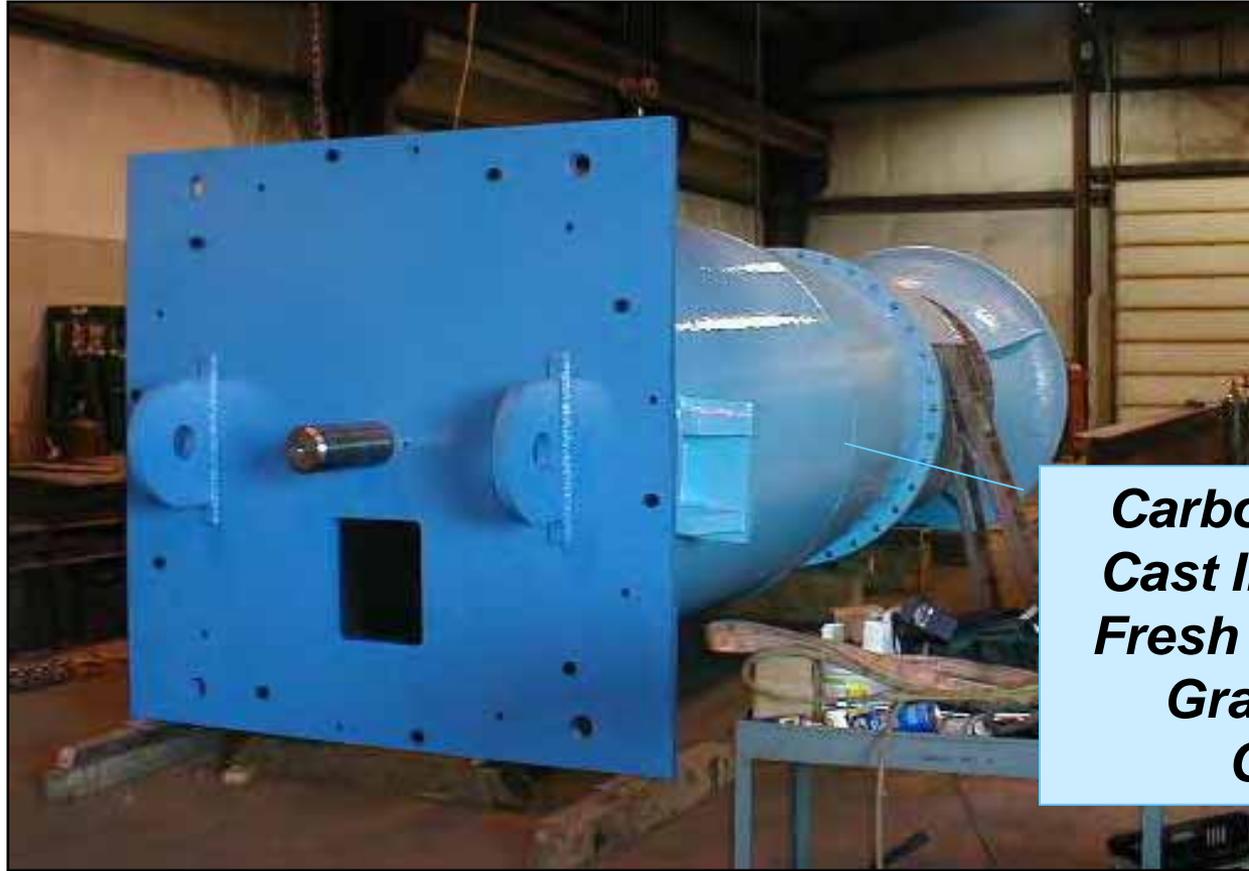
***Carbon Steel and
Cast Iron Pump in
Fresh Water - High
Grade Epoxy
Coating***

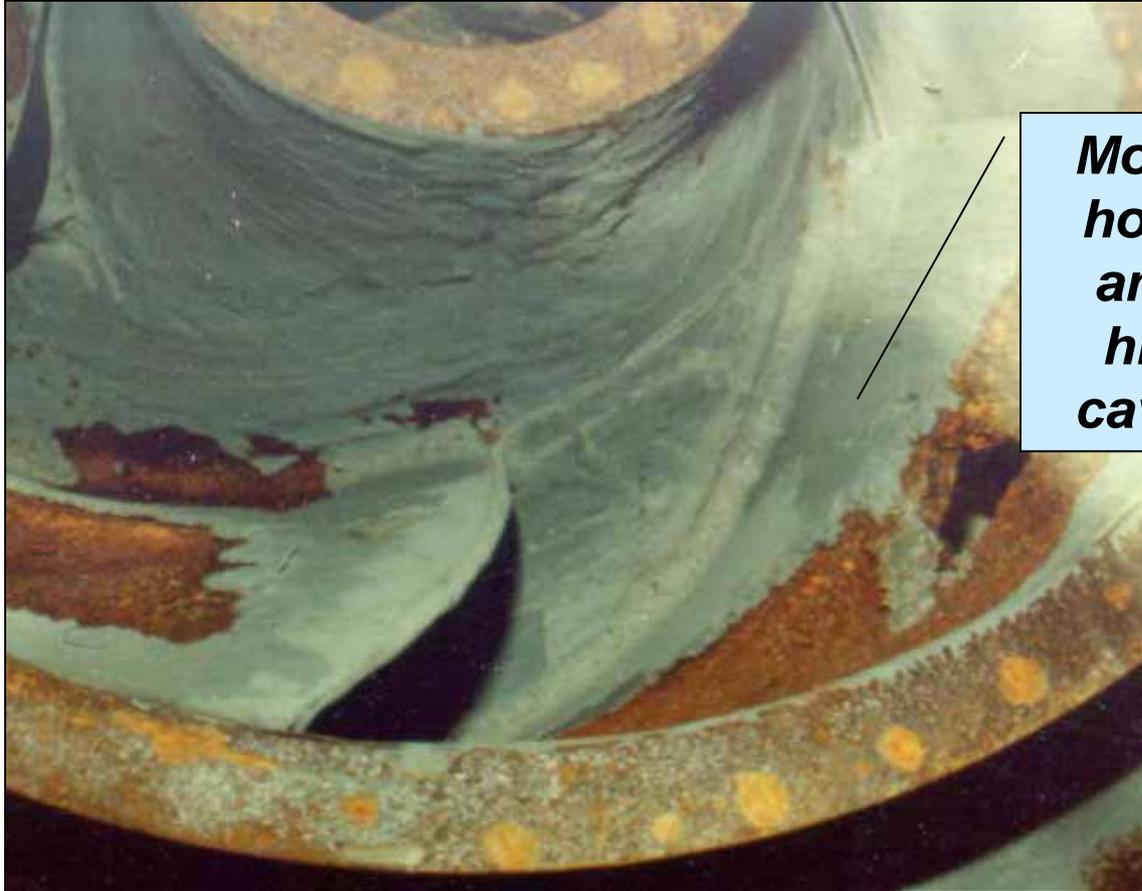
Most coatings do not hold up on impellers and shrouds due to high velocities and cavitation/separation

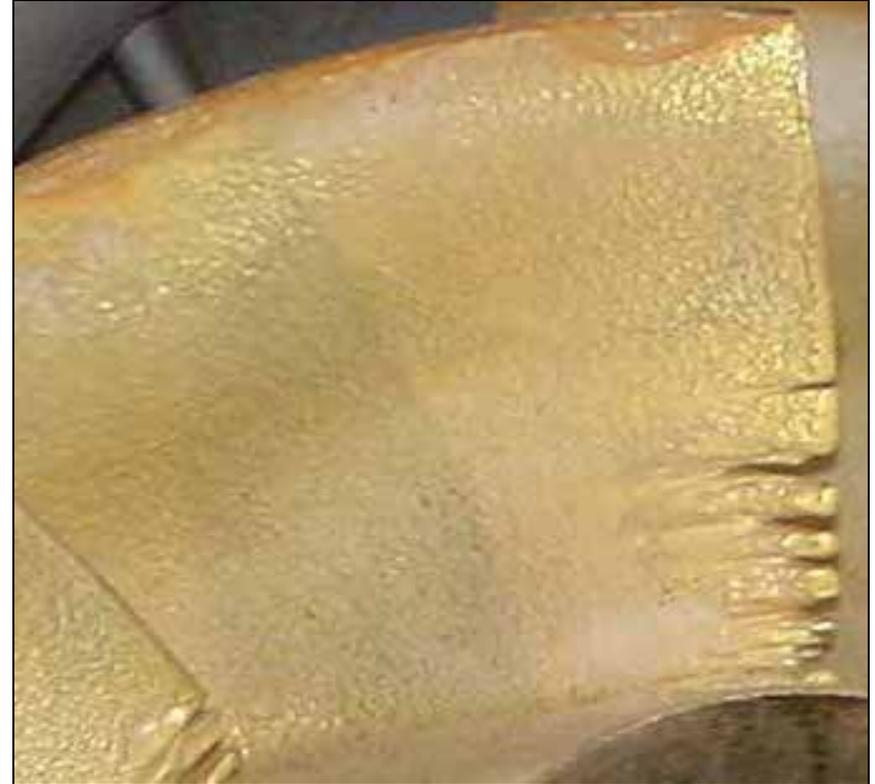
- Symptoms
 - Vane Thinning
 - Saw Cuts at Leading Edge
 - Shallow pock marks
 - Scalloped leading edge

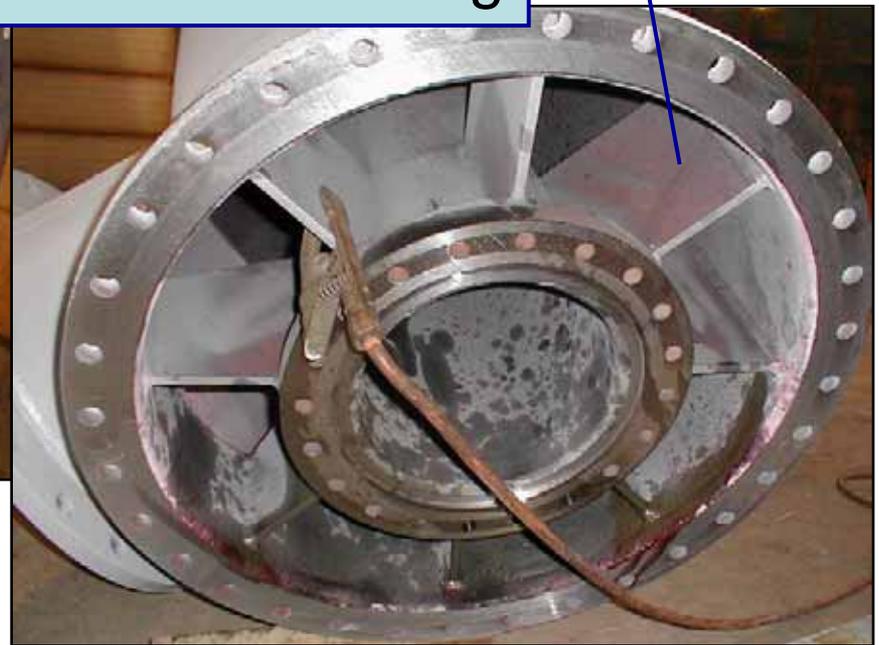
Cracking of support ribs

Beefed up support vanes to eliminate cracking

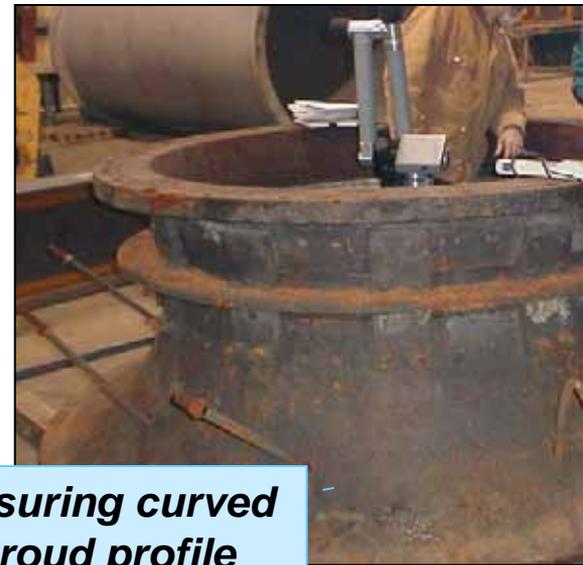
Use the Faro Arm to obtain impeller vane geometry

Faro Arm
Portable Coordinate Measuring Machine

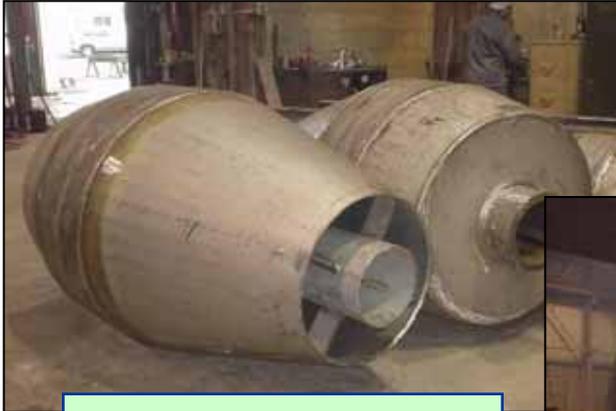
Inner Hubs

Fabrication Steps – 83” Diffusor in 316L SS

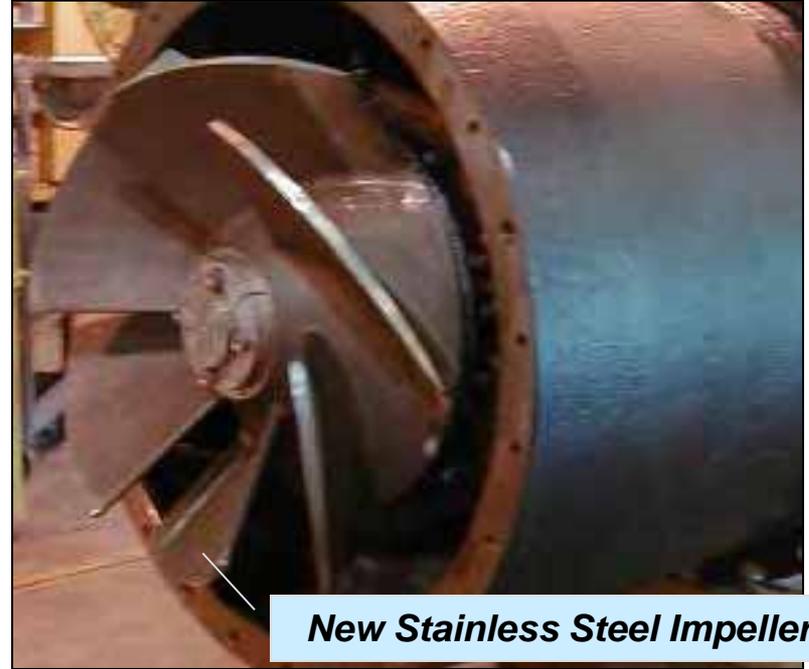
New Stainless Steel Impeller
